CALIFORNIA DEPARTMENT OF FORESTRY AND FIRE PROTECTION SONOMA-LAKE NAPA UNIT

INVESTIGATION REPORT

CASE NUMBER: 17CALNU010045

CASE NAME: Tubbs

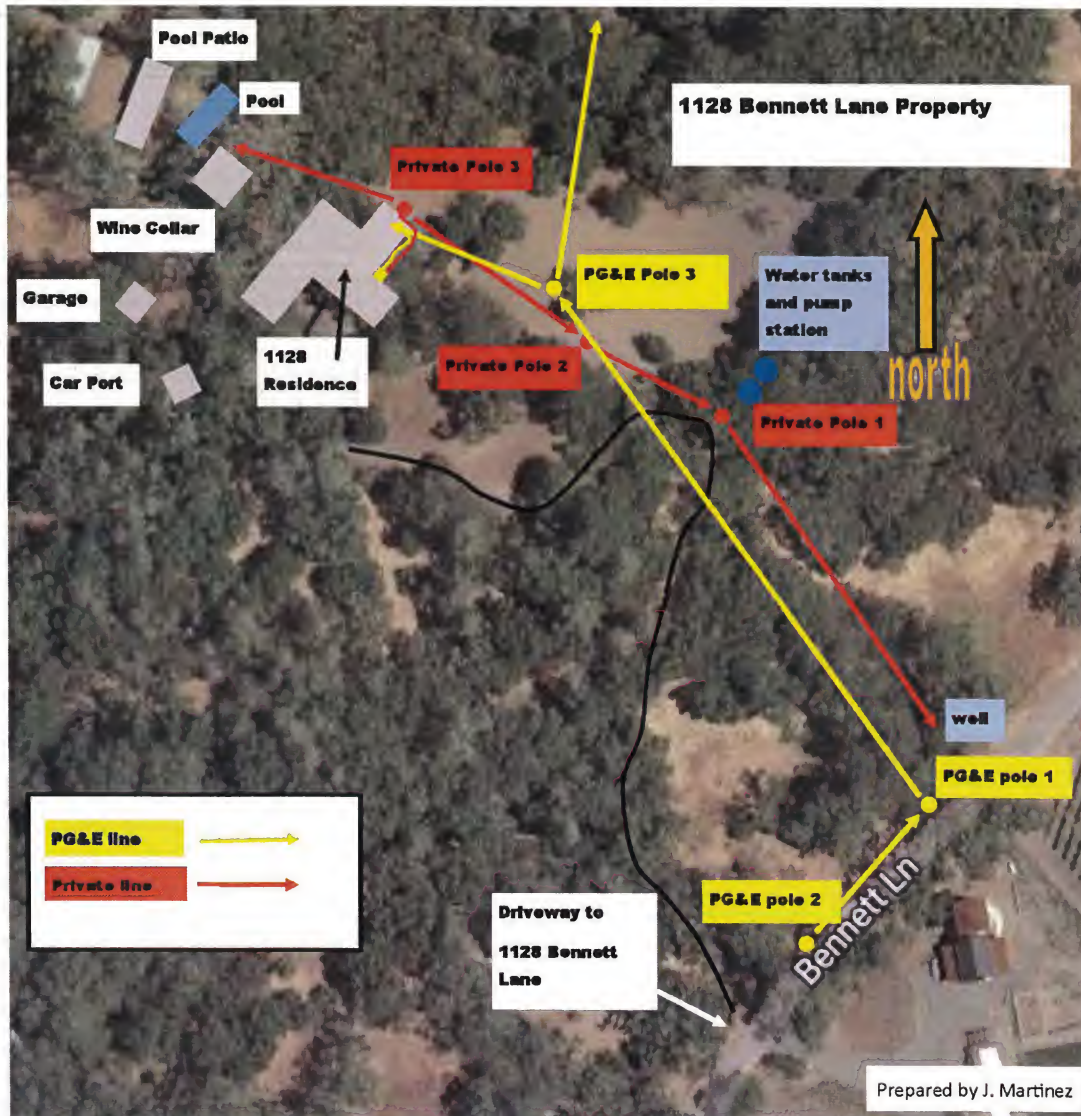
The driveway continues past the cleared area and leads to the upper elevation of the property (approximately 550-foot elevation) where the residence and associated structures sit on top of a hill. The primary residence is located at the end of the driveway. Northwest of the residence is a wine cellar with an attached bedroom. Immediately west of the wine cellar is a swimming pool with an attached open construction pool patio. West of the residence is an open carport and garage. According to accessor parcel data, the residence was built in 1946. The electrical distribution associated with the property includes PG&E service from Bennett Lane uphill to the residence, by service drop to a weather head on the roof. From there, exterior conduit connects to the meter. From the meter, conduit carries conductor to a

1 privately-owned power pole (private pole 3). From private pole 3, conductor extends
2 north west towards the wine cellar and pool patio. Additionally, from private pole 3,
3 conductor extends southeast towards private pole 2, then to private pole 1 where the
4 water tanks and pump station are located. From private pole 1, conductor extends
5 downhill where it ties into a well next to Bennett Lane. The graphic below includes a
6 general representation of the developed property at 1128 Bennett Lane with a general
7 schematic of the electrical system.
